Analysis of CT Scans of the Stewart-Jones Hockey Stick  
Andrew J. Nelson  
Department of Anthropology  
The University of Western Ontario  
London, ON

Report prepared for  
Harold Butler  
Instructor Humanities, Business & Entrepreneurship  
Bernice MacNaughton High School  
Moncton, NB

May 10, 2019

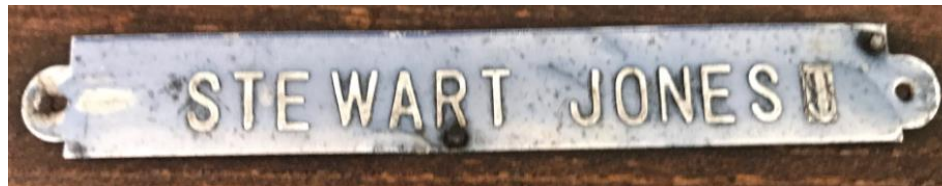
Brousseau's EDS analysis suggested that the plate is high quality cast aluminum. A recent scan of an aluminum square .65mm thick yielded a mean Hu value of 628.5 (std dev = 668.5). This plate is 1.2mm thick – so one would expect a comparable value. The mean for the name plate is within 1 standard deviation of the aluminum square, but it is lower. This may indicate that there is some corrosion of the plate that is not visible.

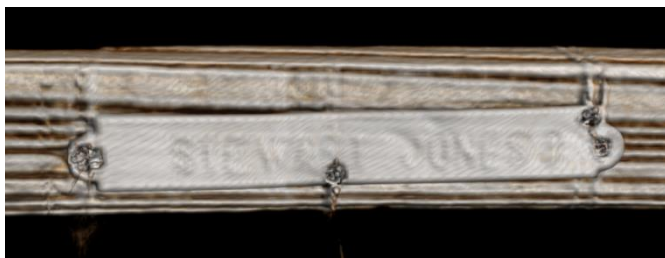
3D rendering of the name plate from the CT scans

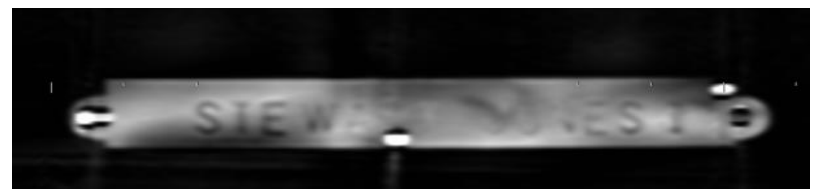
Slice view of the name plate shows that it is of uneven thickness

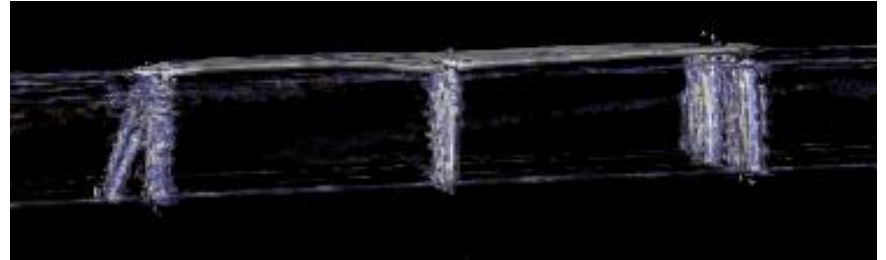
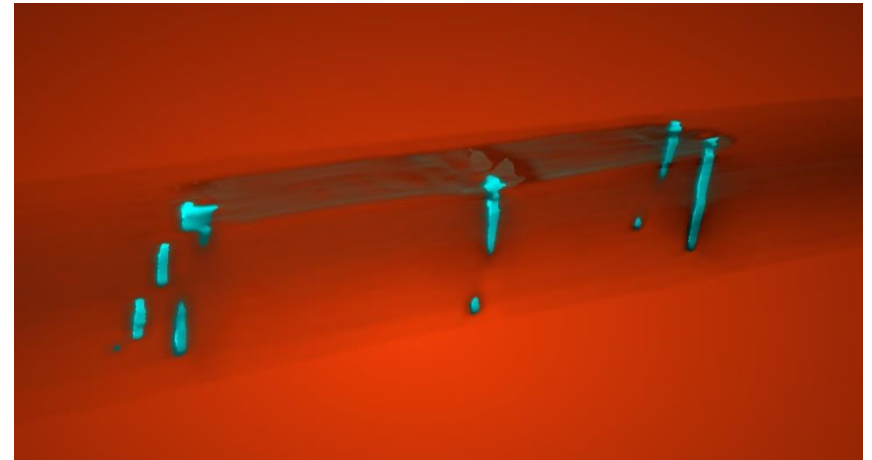
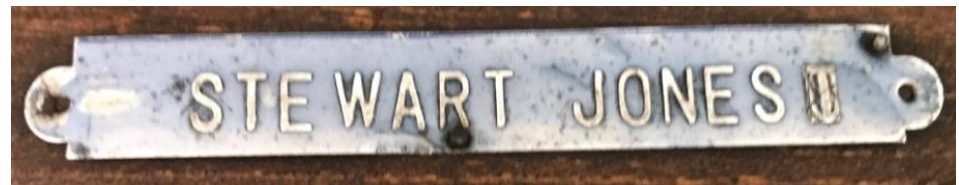
## Name Plate continued

3D renderings of the nails show that the metal that they are made of is denser than the aluminum plate. HU values determined from an ROI in the center of one nail yields a mean Hu value of 1875 (std dev 1065). A recent scan of a steel square .74mm thick yielded a value of 886.5Hu (std dev Hu 732.8. These nails are, on average, more dense than the steel square, but the values are within a standard deviation of each other. Thus, the densities are consistent with Brosseau's EDS analysis suggesting that they are iron.

Note that there are fragments of iron visible deep in the wood that do not connect with the nail heads visible in the name plate. This suggests that this, or another, name plate had previously been attached to the stick, and the nails broke during removal, leaving fragments behind.

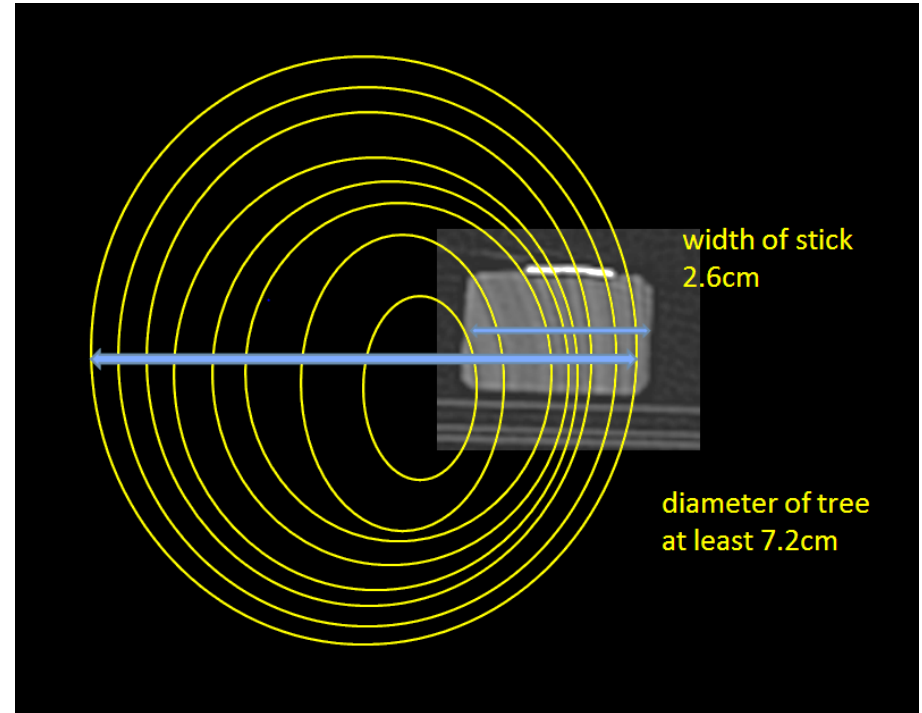
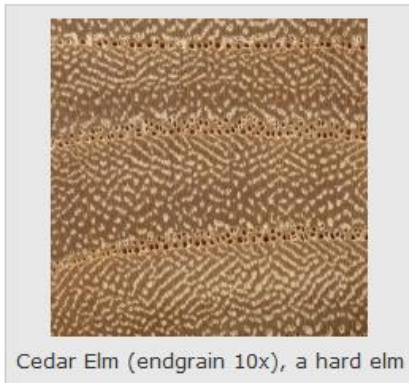
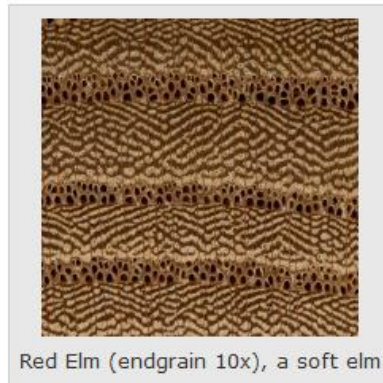
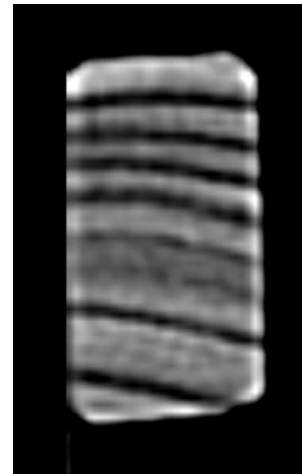
## Rings

Extrapolation of the tree rings suggests that the tree from which this stick was made was at least 7.2cm in diameter with slightly eccentric rings.

Pilon identified the wood as Elm (*Ulmus*), but she did not identify a specific species. The rings of this stick are very porous, which is consistent with the soft elm species rather than the hard elm species (see <https://www.wood-database.com/wood-articles/elm-wood-hard-and-soft/>)

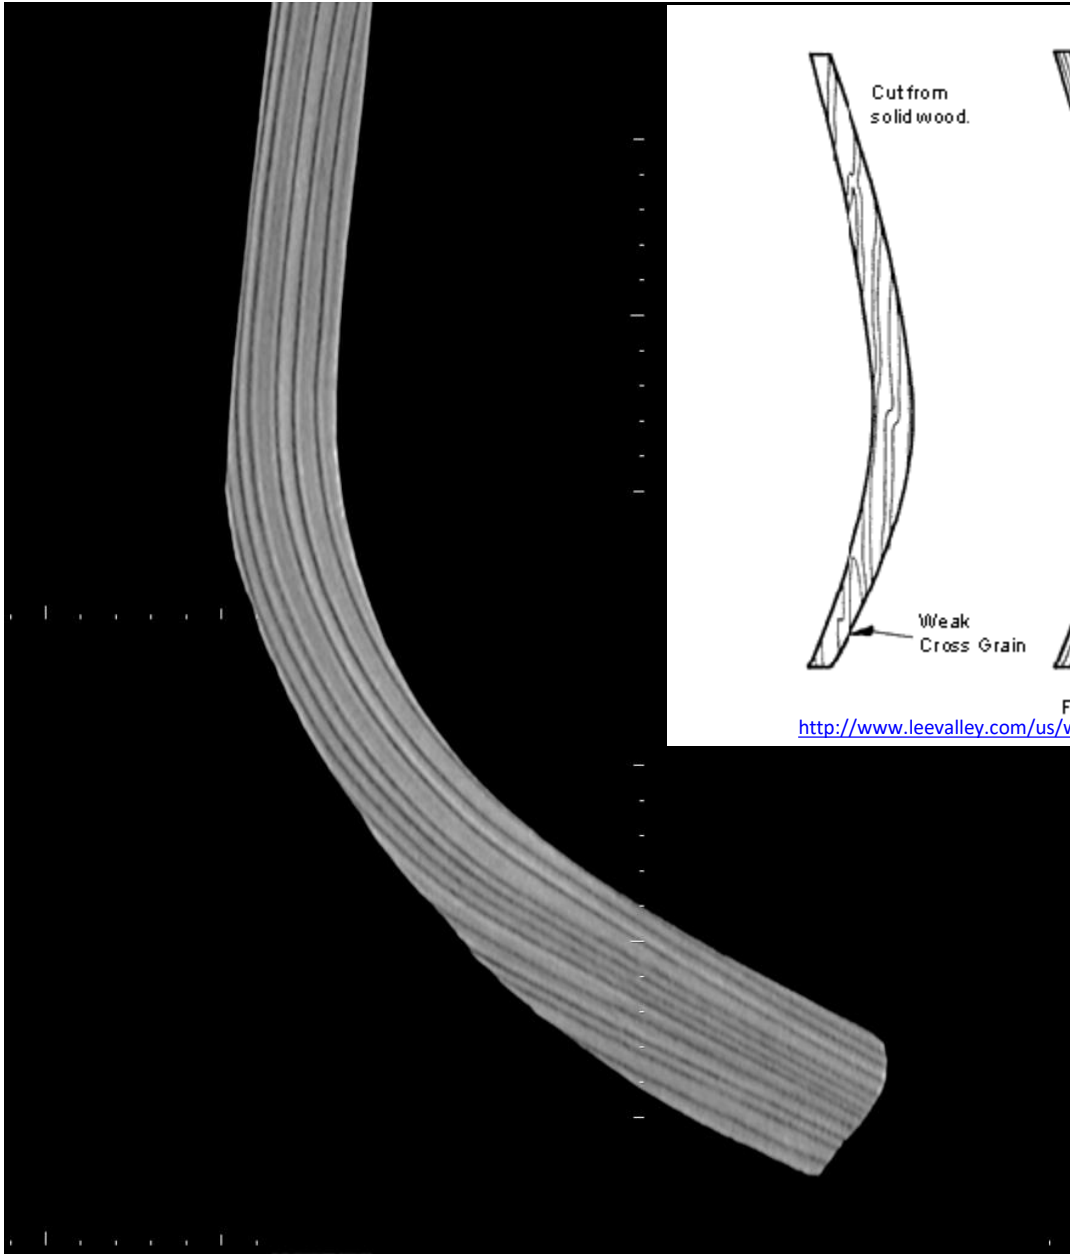
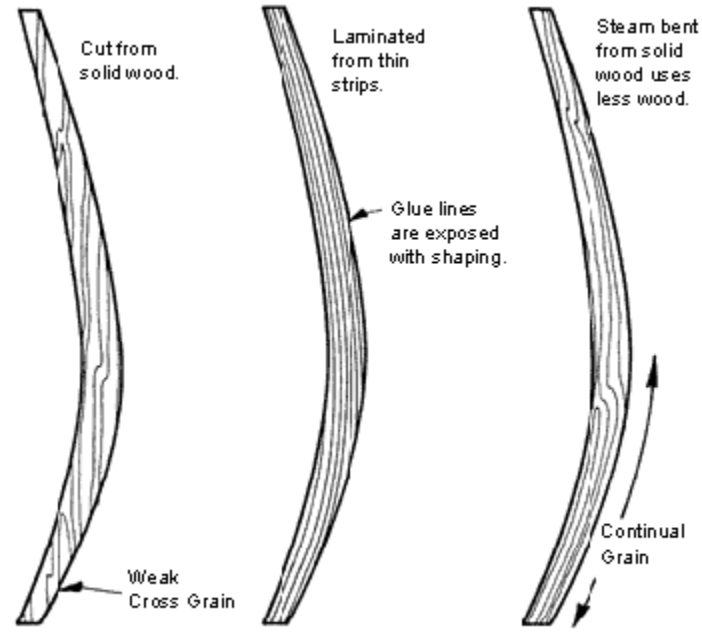
Figure 4

The continuity of grain along the shaft and around the heel to the blade is consistent with the use of steam to bend the wood.

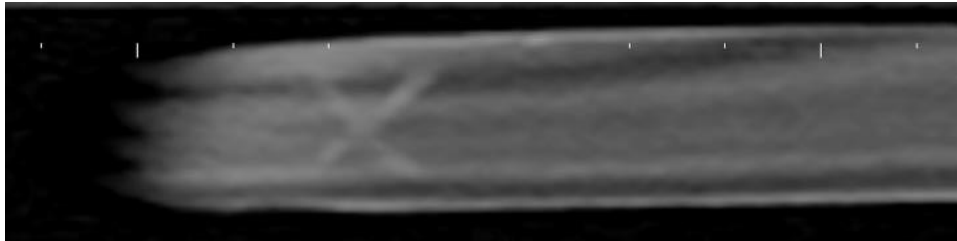
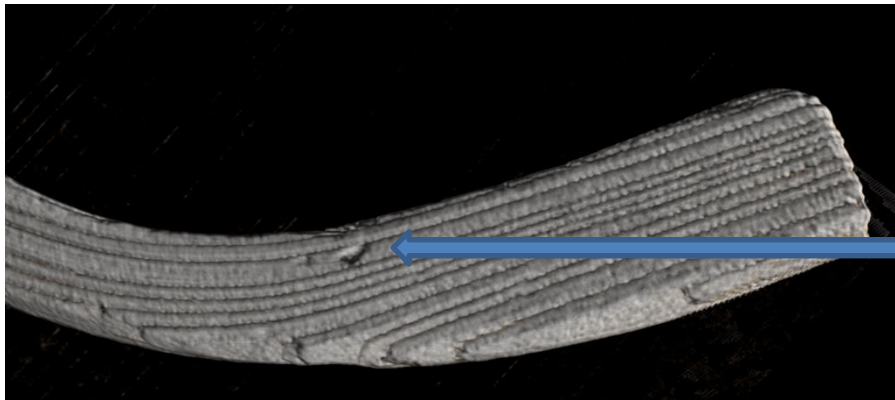
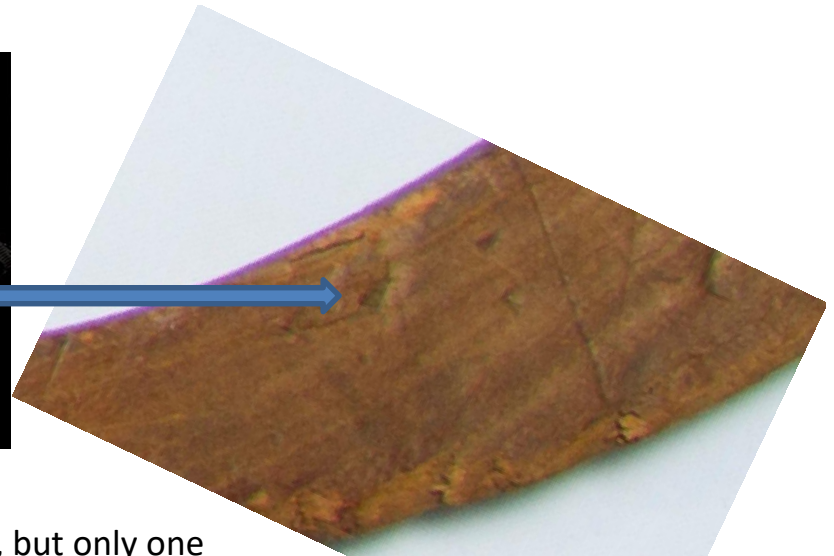
This image shows the increased density under the owner's X mark. This is caused by slight crushing of the wood matrix, making it appear more dense.

There are several linear features on the blade of the stick, but only one defect that is visible on the scans. That suggests that they were caused by an impact or action less forceful than that which made the X on the handle. There is nothing visible on the photo or on the scan data that would suggest an impact with a hard puck.
